REPORT ON THE LARGE-SCALE FIRE PROPAGATION PROPERTIES OF 80 mm THICK EXPANDED POLYSTYRENE (FR GRADE) UNDER- ROOF AND SIDE CLADDING INSULATION MATERIALS USING THE SANS 10177-11 TEST METHOD

3. PURPOSE OF THE INVESTIGATION

The purpose of the investigation was to evaluate the large-scale fire propagation properties of 80 mm thick expanded polystyrene (EPS) boards as an insulated system for thermal insulated building envelopes. The insulating system was tested for both under-roof and side cladding applications. The fire propagation properties of the thermal insulation system were also determined when installed in conjunction with a fixed sprinkler extinguishment system using slow response sprinkler heads.

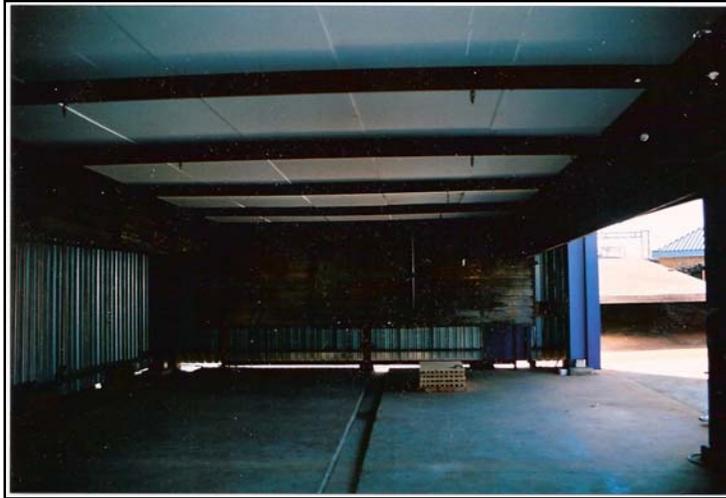
Figure B1-1: Installation prior to ignition of fire source

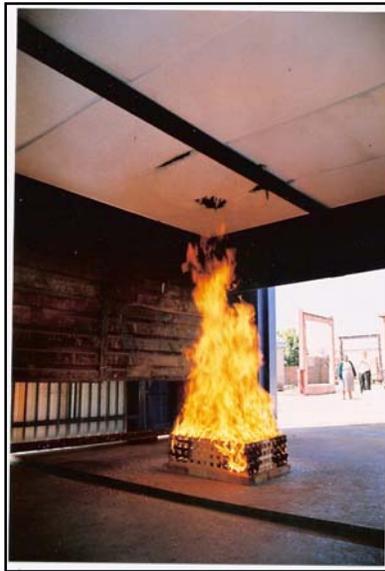
Figure B1-2: Material deforming and opening up in area above heat source (t = 4 min)

Time (min:sec)	Observation
0:00	Ignition of SA Pine ignition source.
3:52	Deformation of insulation panel above and around ignition source noted.
4:17	Deformation of material up to first purlin (2m) – no flaming.

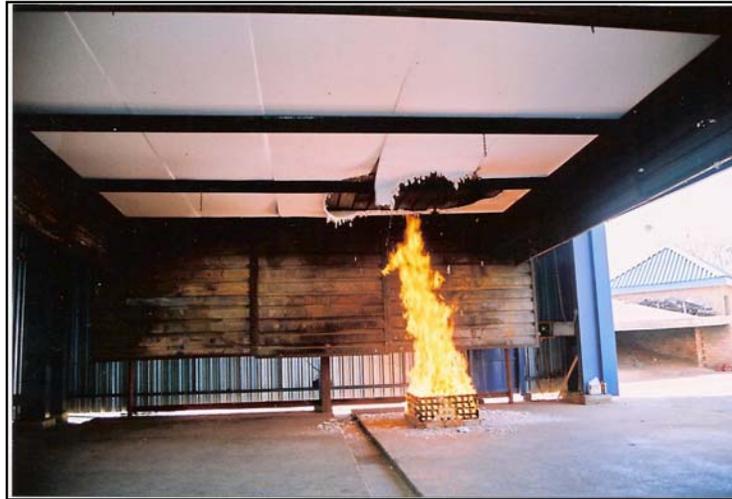
Figure B1-3: Larger area above fire source damaged but no ignition (t = 8 min)

The evaluation also showed that no ignition of the insulation took place during the test and that the heat damage was limited to first four metres of the installation. Although all the material in the installation was pre-heated by the fire source, only shrinkage of the joints was visible on the second 6 m x 6 m panel of the test installation with the last 6 m x 6 m panel remaining undamaged.

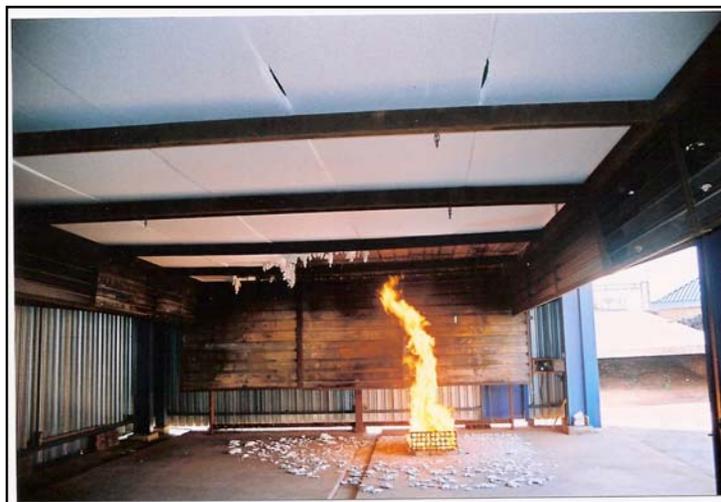
Figure B1-4: Fire source decaying – no further spread of damage to installation (t = 15 min)

13:24	Most of the material in the first section of the front panel have either dropped out or have distorted.
14:40	Material melted away on the surface of the second section of the front panel while also pulling away at the joints. No flaming noted.

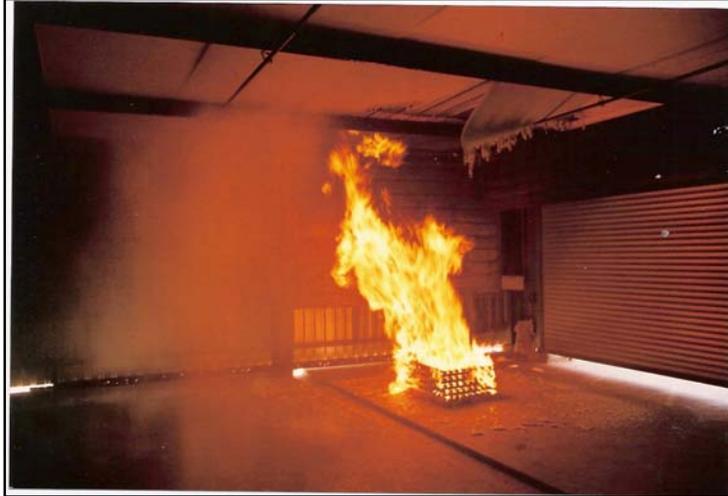
Figure B2-3: First sprinkler activated and operating unhindered (t = 7 min 30 s)

Time (min:sec)	Observation
0:00	Ignition of SA Pine ignition source.
3:08	Deformation and melting of the material noted above the ignition source.
4:10	Material dropping down onto the floor of the facility.
7:26	The first sprinkler activated.
9:37	The second sprinkler activated.
13:05	The ignition source starting to collapse
15:00	The sprinklers were de-activated while the ignition source continued to burn.

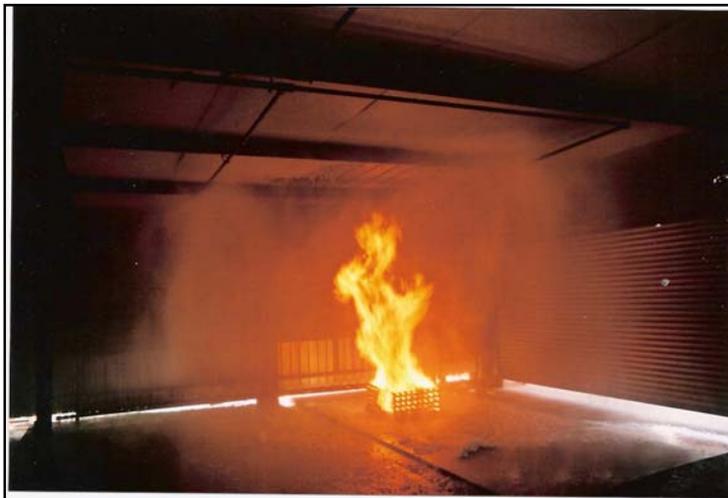
Figure B2-4: Second sprinkler activated, no further damage to test installation (t = 9 min 30 s)

During the evaluation where a sprinkler system was installed, the damage to the material where notably less than during the evaluation without sprinklers. As before, no ignition of the material occurred. It can be stated, therefore, that the sprinkler activation decreased the heat damage to the insulation material. It was also shown that the insulation material did not affect the efficiency of the sprinkler installation.

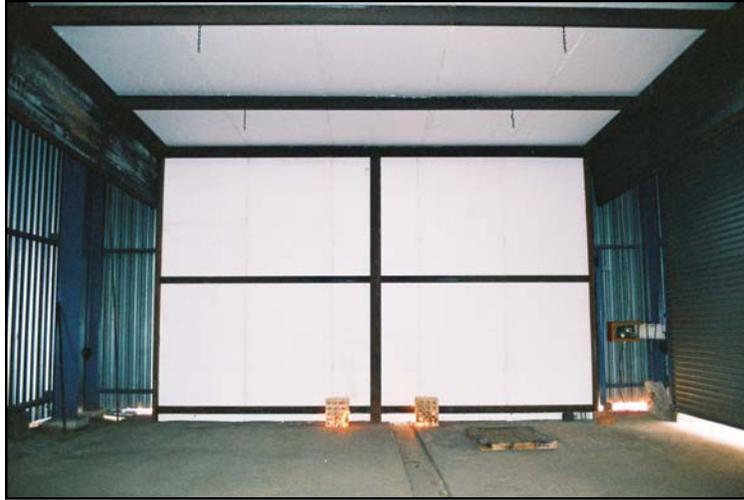
Figure B3-1: Test installation shortly after ignition of fire sources

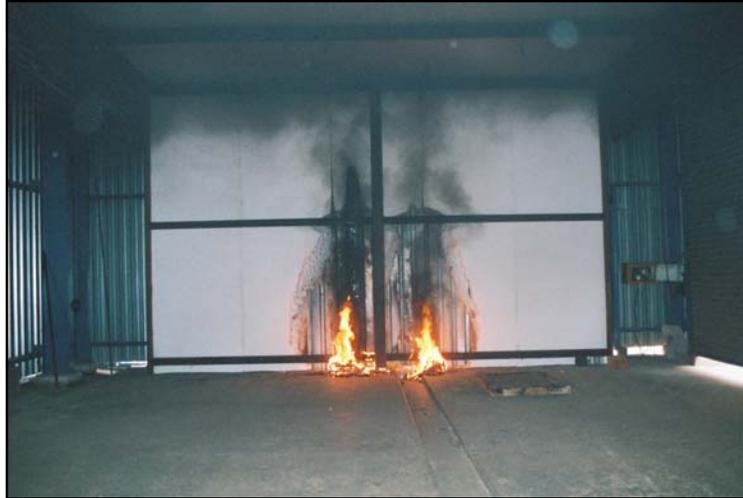
Figure B3-3: Starter packs collapsed against installation with some fallen material burning between bottom purlin and IBR sheeting (t = 19 min)

16:00	Left-hand ignition source collapse against the insulation.
16:43	Right-hand ignition source collapse against the insulation.
18:36	Flaming of the material noted between the bottom purlin and the IBR sheeting.

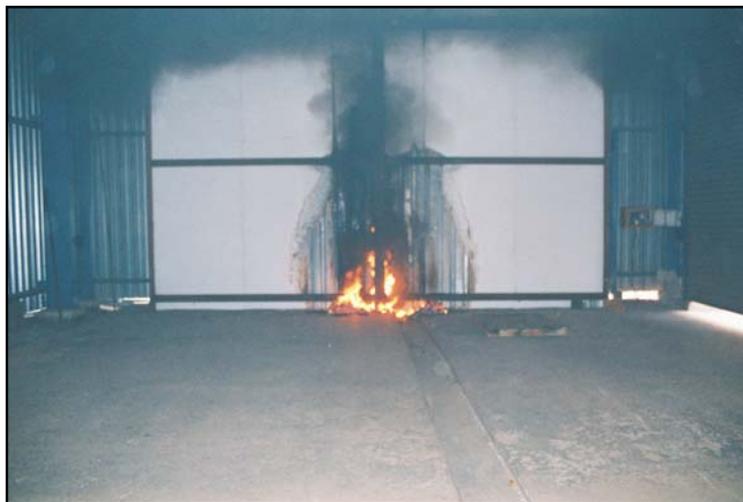
Figure B3-4: Limited flaming along vertical support element (t = 22 min), which seized at t = 24 min)

22:00	Slight vertical flame spread between the collapsed ignition sources and the vertical support element noted. Flaming was limited to approximately 1m above the ignition source

24:00	Ignition sources nearly burnt out with flaming of the insulation material having stopped.
